Manhole Inspection Summary

Manhole # S39I__039MH

Insp Date: **7/9/08 9:20 AM**

Location Address: **221 s. high st**

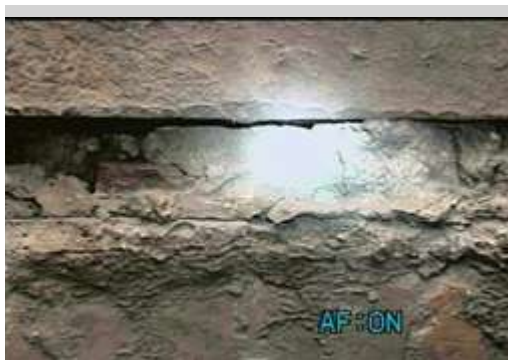
Defect 5

Condition: ☐ Sound ☐ Cracked ☐ Root Intrusion ☒ **Loose Brick** ☒ **Deteriorated**

chimney cond loose bricks, deteriorated

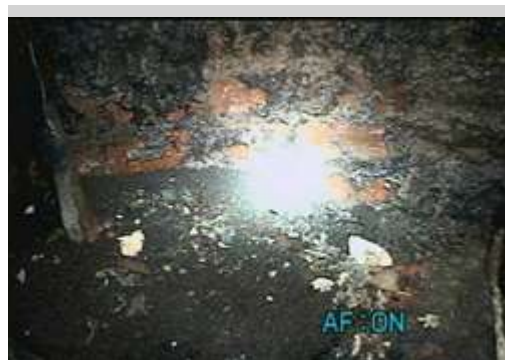
Defect 4

Condition: ☐ Sound ☐ Cracked ☐ Root Intrusion ☐ Deteriorated ☐ Leaks ☒ **Debris**

bench debris

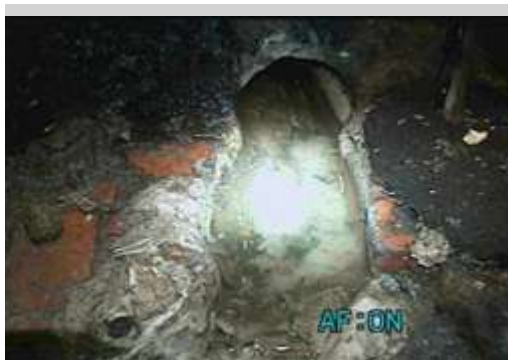
Defect 3

Condition: ☐ Sound ☐ Cracked ☐ Root Intrusion ☐ Deteriorated ☐ Leaks ☒ **Debris**

channel debris

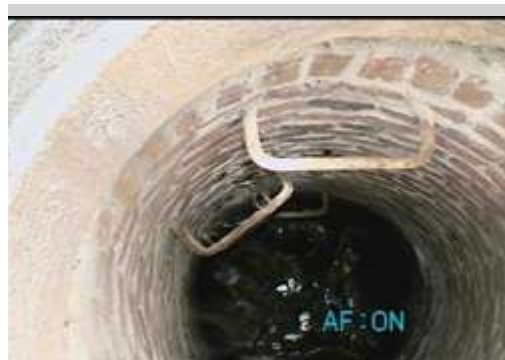
Defect 2

Count: **7** Missing: **1** ☒ **Corroded**

corroded steps & 1 missing

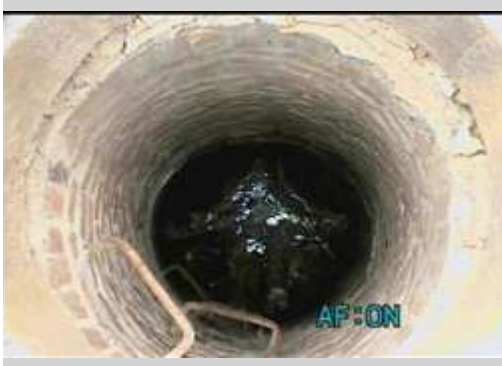
Defect 1

Offset: **3** (in.)

Frame Offset 3"

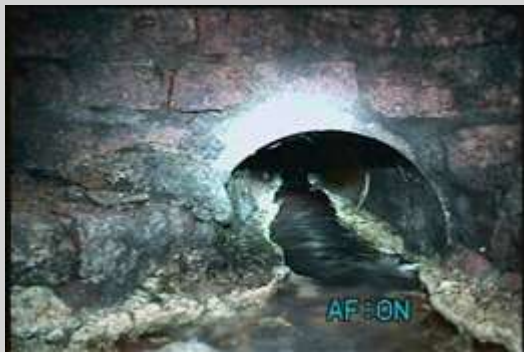
12 O'Clock Outflow

Deposits: ☐ None ☐ Mud ☒ Sludge ☐ Debris ☒ Grease

Silt Depth: 5 (in.) Deposits Extent: **Medium**

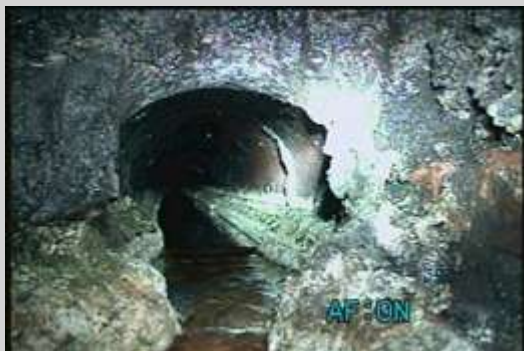
3 O'Clock Inflow

Deposits: ☐ None ☐ Mud ☐ Sludge ☐ Debris ☒ Grease

Silt Depth: 0 (in.) Deposits Extent: **Medium**

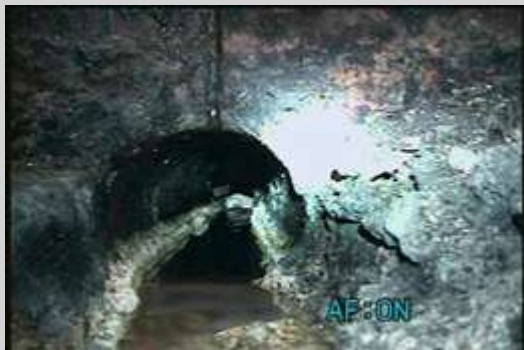
9 O'Clock Inflow

Deposits: ☐ None ☐ Mud ☐ Sludge ☐ Debris ☒ Grease

Silt Depth: 0 (in.) Deposits Extent: **Medium**
